THE SAD SORRY SEWAGE SAGA - 29nd April to 3rd September 2021

(And a few years before that..... Decades)

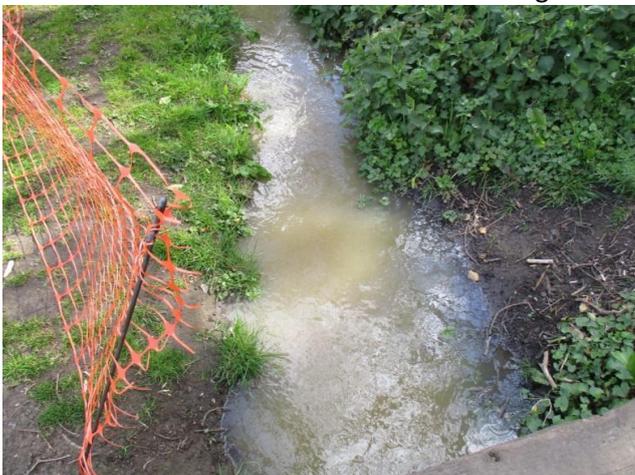
Recreation Ground Stream with sewage

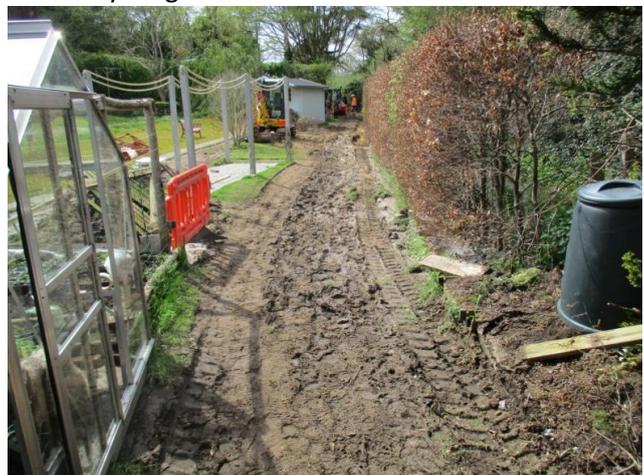
Sandy Ridge Site

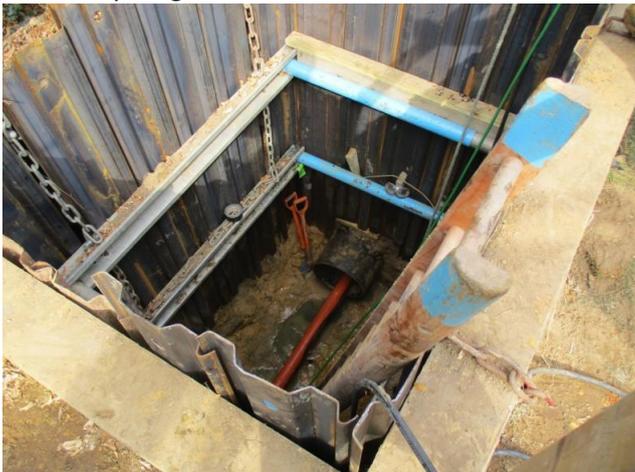
First Sandy Ridge Excavation

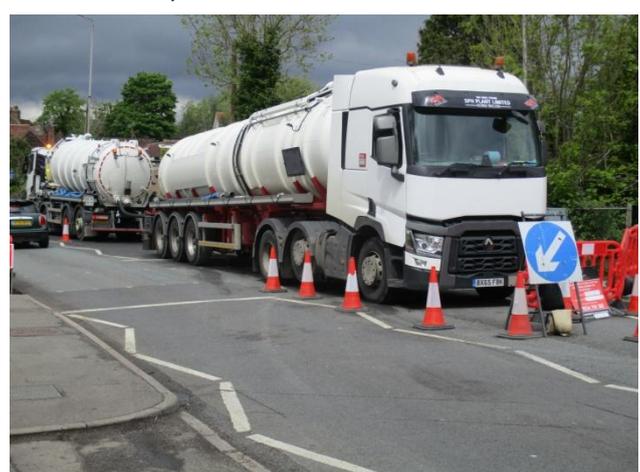
24/7 tanker operation at Maidstone Rd

The Maidstone Pumping Station has had to be shut down to allow work on the damaged pipe, and this has necessitated a huge fleet of sewage tankers bypassing the pipe from Maidstone Rd, Basted and Ightham, and running sewage directly to the Ham Hill Sewage Works at Snodland day and night.

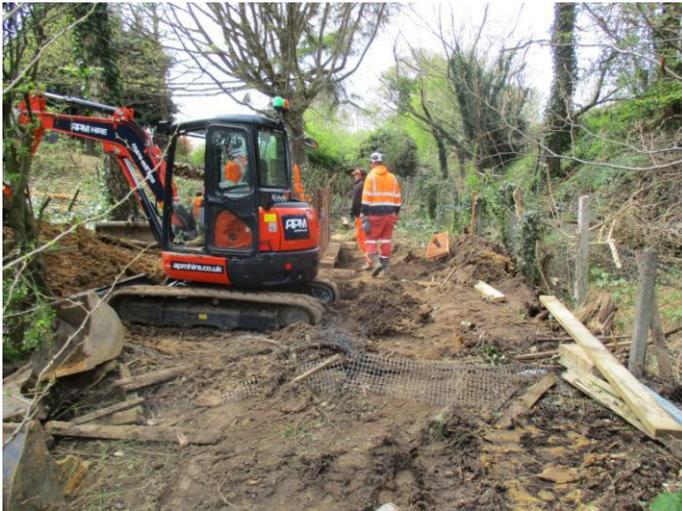
Site of third sewage breakout

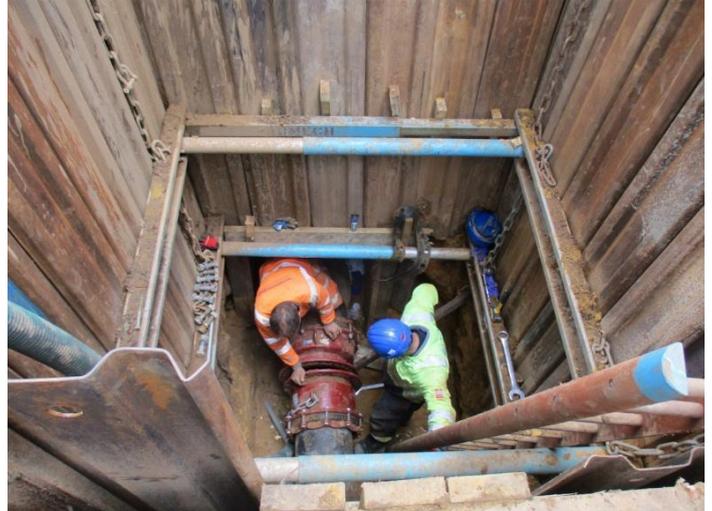
Third and fourth beakouts

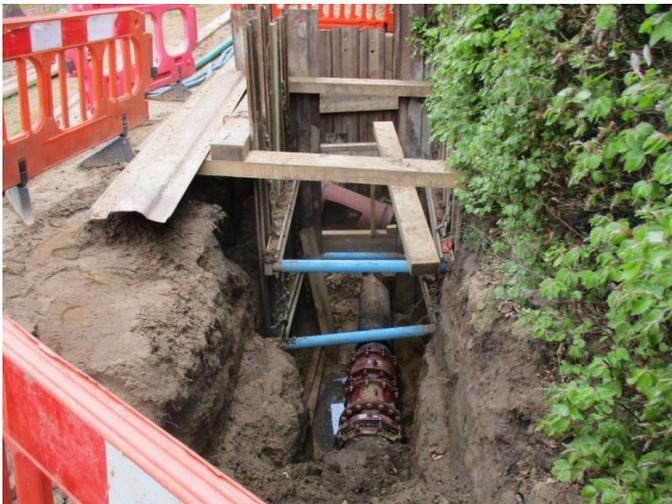
Second Excavation extended for pipe insertion

Borough Green has suffered for decades from sewage blowouts and sinkholes, people's houses and garden flooded on a regular basis. But things came to a head in 2021. Between 29 April and the 29th May we have had **seven** successive breakouts on the main sewage line between the Maidstone Rd Pumping Station and its eventual route past Whatcote Cottages and Askew Bridge to Wrotham Heath. These breakouts have all happened in a garden of a house on Sandy Ridge, and there is a major Southern Water operation taking place there. The proposed solution that we have been advised of today is that a 25 metre sleeve will be inserted in the damaged pipe to ensure sewage cannot escape again.

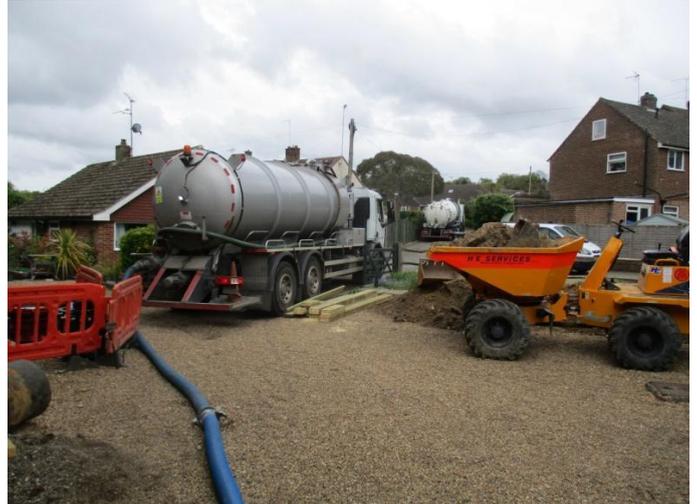
Standby tankers keeping excavations clear

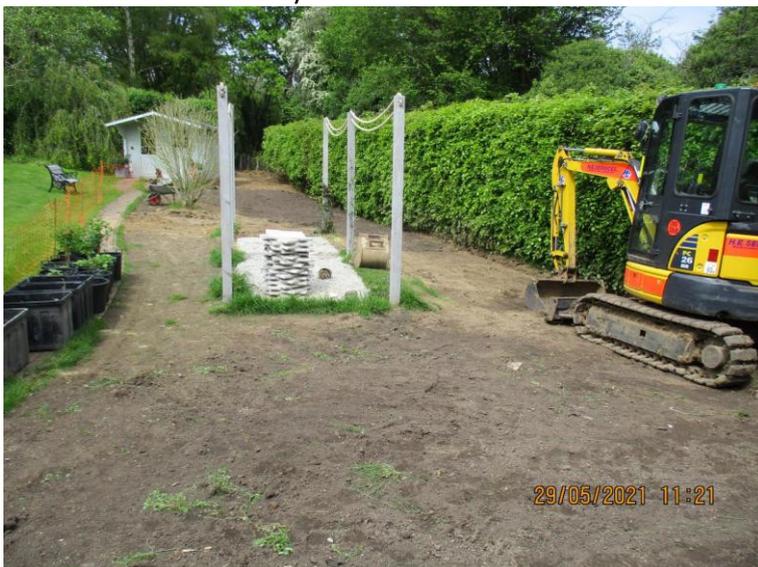
Reinstatement underway

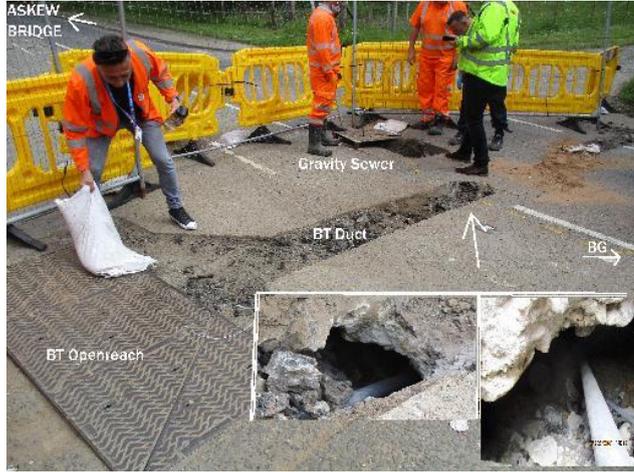
Southern Water engineers were called, closed the road, and began investigations with CCTV and Ground Penetrating Radar, finding a 5mtr square void, 3.5 mtrs deep under the main A25.

KCC and SW investigate the collapse

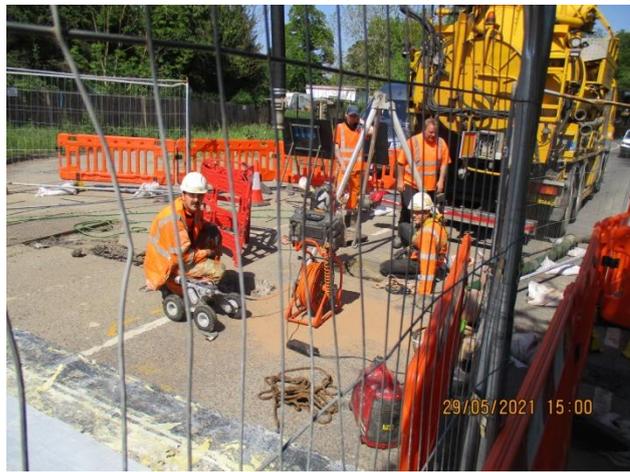
Specialist team CCTV survey the pipe and prepare a Resin Repair

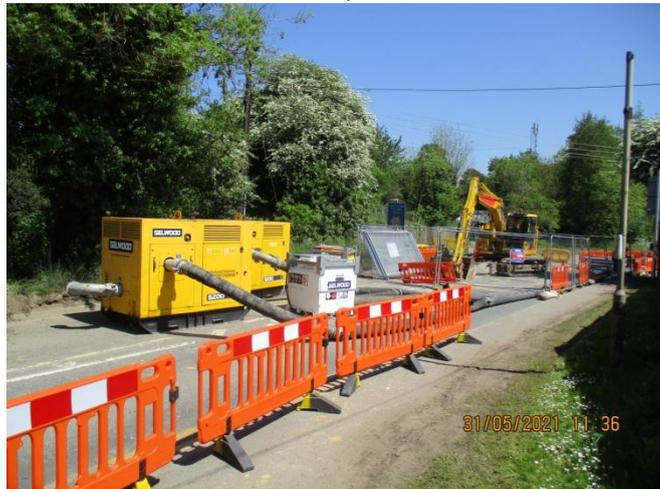
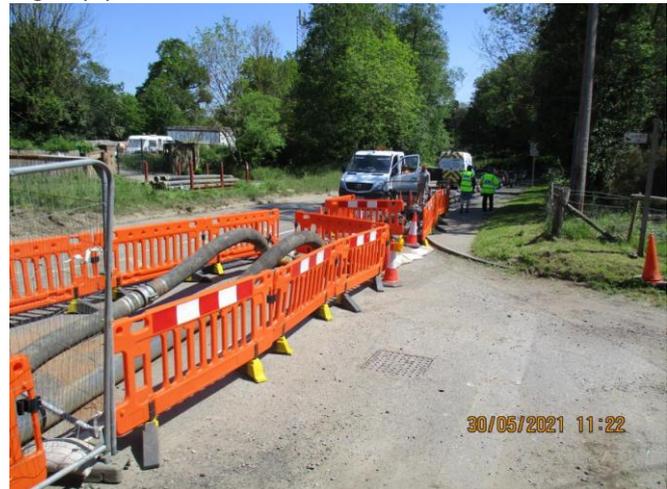
After an initial repair it became apparent that there was a further 350 metres of collapsed and blocked pipe past Askew Bridge. A pair of heavy duty silent pumps were brought in to transfer sewage via two pipes to a manhole near Clubb's entrance, to allow repairs to be made to the damaged pipe

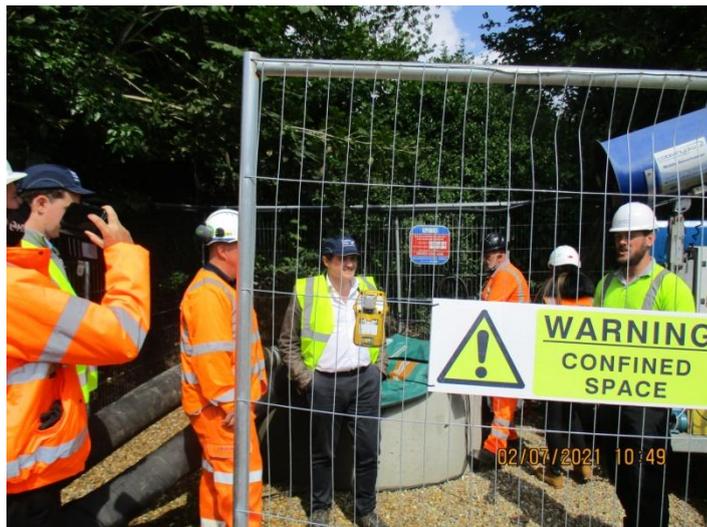
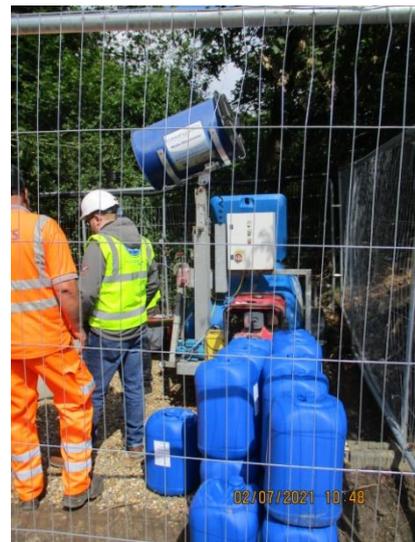
Tom talking to Andy SW and Stuart of Cappagh Brown, to the right the industrial Air Freshener . The green sheeted object behind Tom is the suction point for the transfer pipes

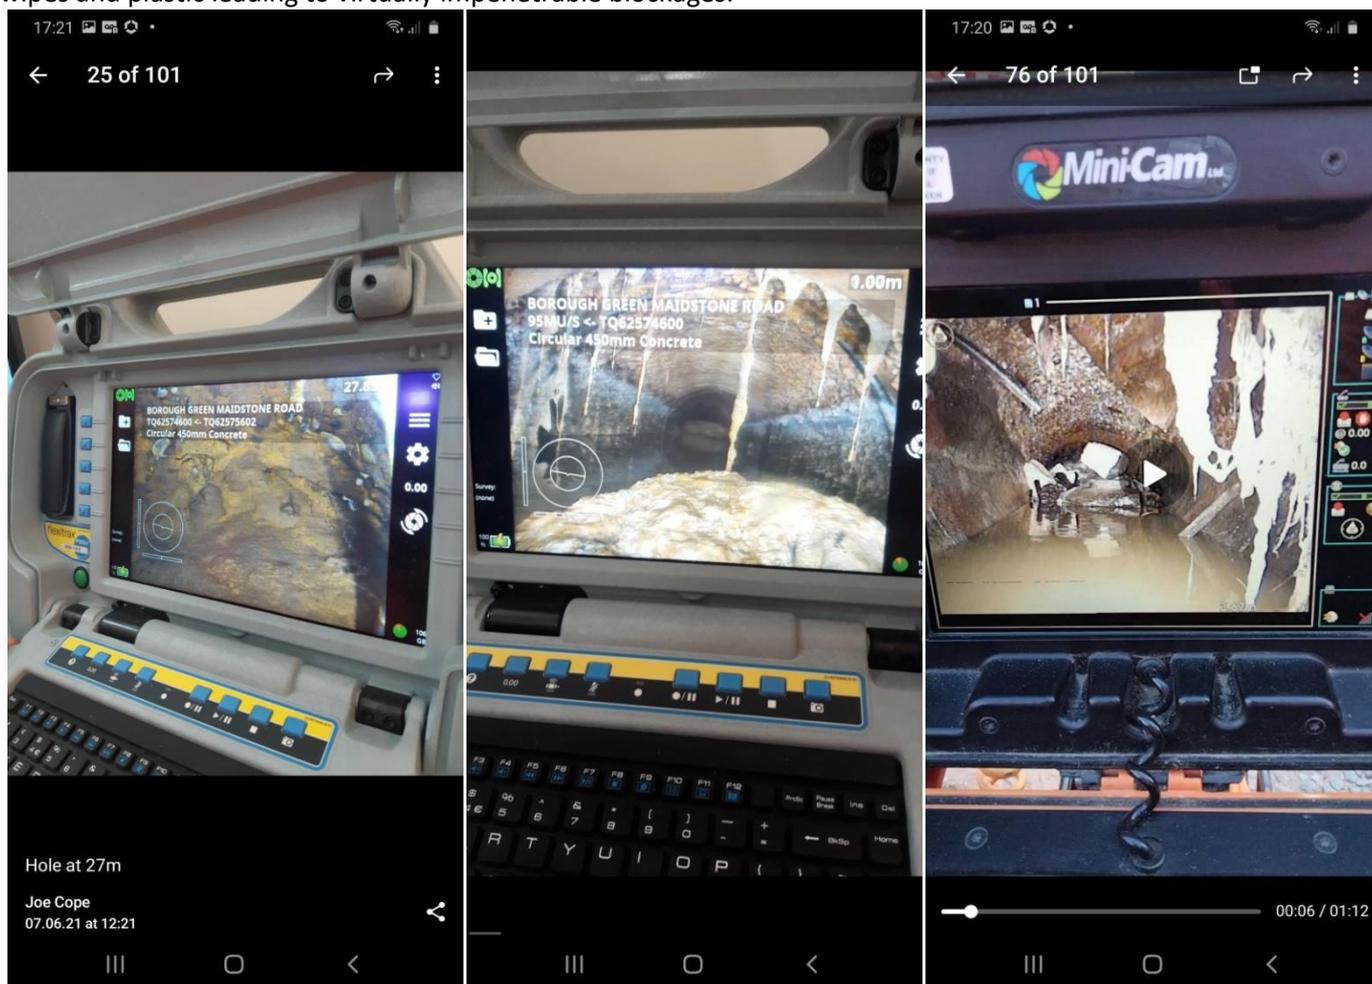
Below are CCTV images of the inside of the damaged pipe. Over the years Sulphur Dioxide gas from the sewage has rotted the 1929 concrete, allowing the ingress of soil and dirt. That build up has caught solids in the sewage such as wipes and plastic leading to virtually impenetrable blockages.

The plan is to thoroughly clean the pipe, and then insert 350 metres of a plastic structural liner, which should be delivered in the next 10 days, followed by rebuilding manholes, testing and the like.

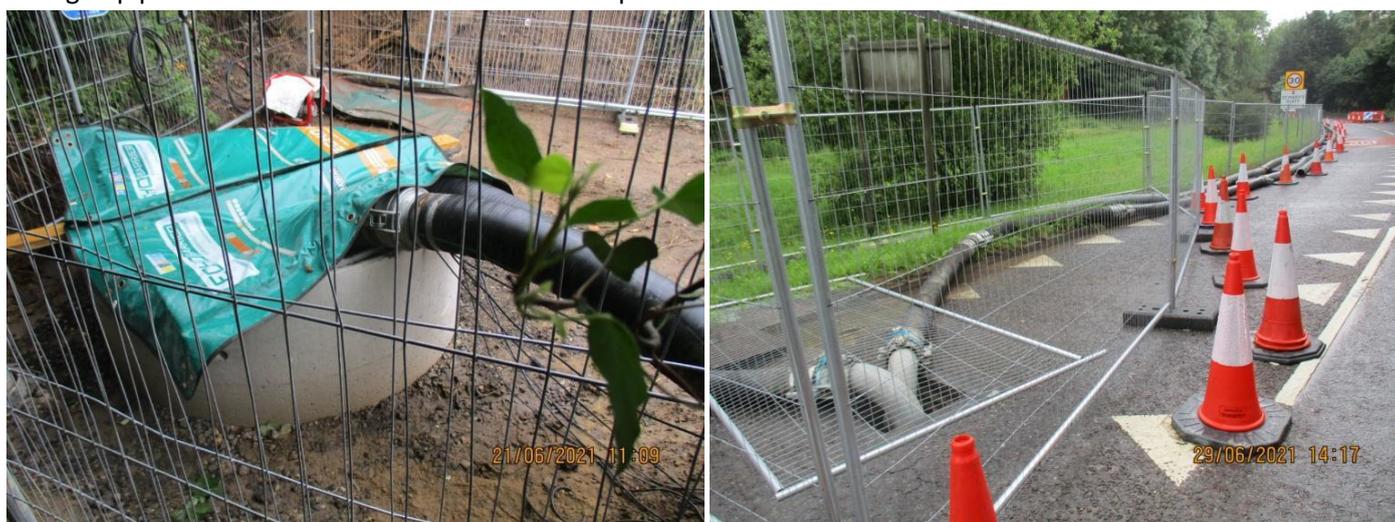
The pipe failure at Askew led to both the wash out void under the A25, and the blockage of the Main Sewage Line. Below pictures show the suction point near Glebe Cottage, and also where the pipes re-enter the system near Nepicar Sandpit . Two massive pumps are carrying the sewage through surface pipes to that distant manhole, so the damaged pipe can be cleared and readied for the repair.

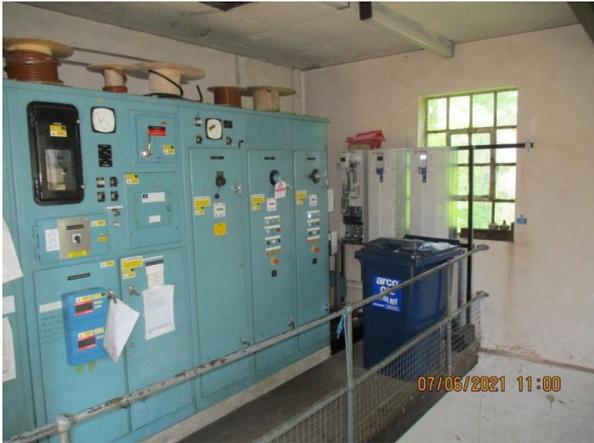
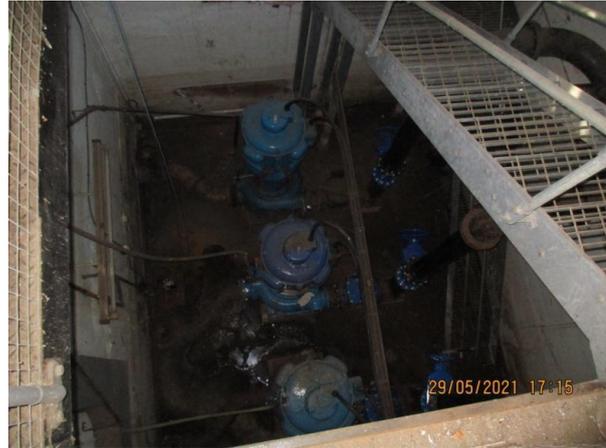
The grey cabinets by the window are the new Variable Speed Controllers that will ensure that the pumps will "soft start", and not with a "bang" that can rupture older pipes. To the right are the three upgraded pumps.

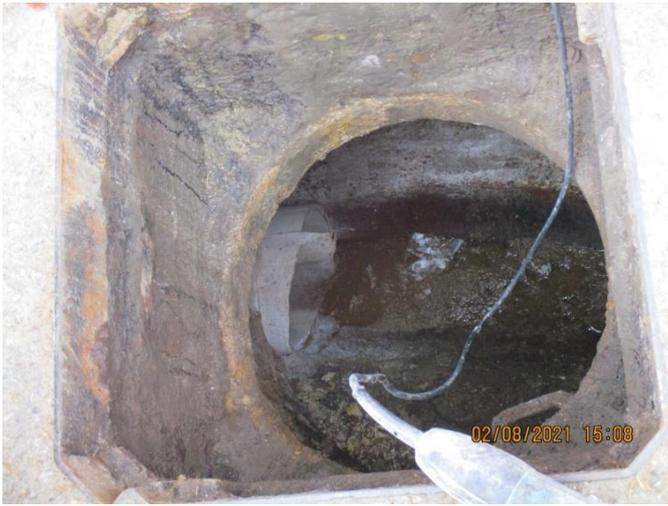
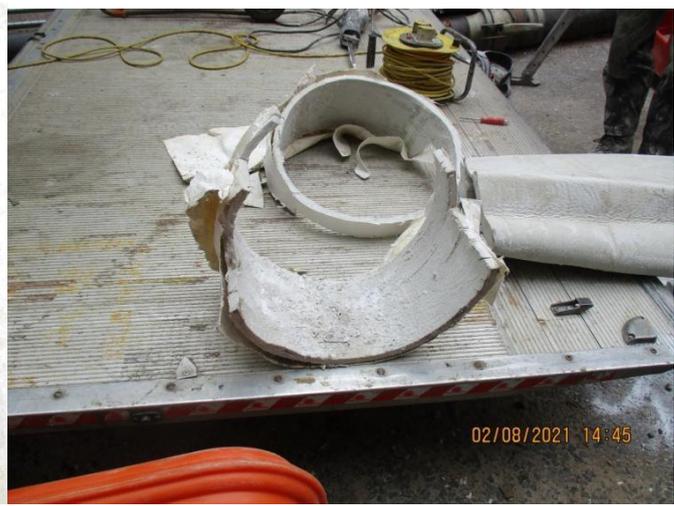
I had been wondering how they were going to even deliver 350 metres of pipe in one piece, never mind how they got it down the tiny manhole and 90 degrees into the pipe. It all became clear with this picture - it arrives flat and flexible, is manoeuvred into place in the pipe, and then inflated and heat cured in situ.

View down a manhole showing the new liner on the left, and some off-cuts of liner

After the pipe has cured, holes are cut at the manholes, and a special device cuts the holes where domestic pipes are connected.

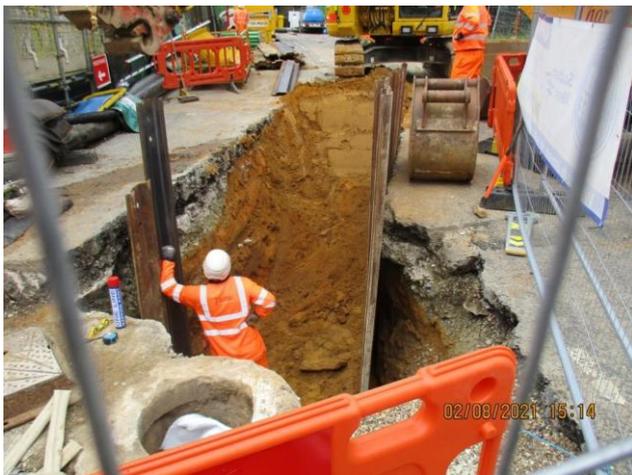
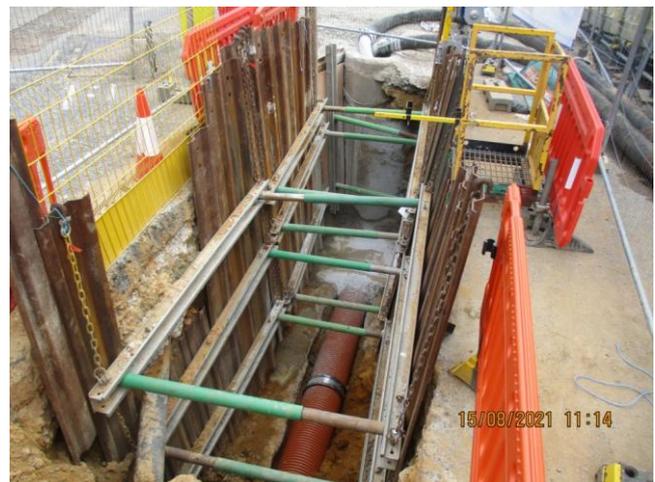
The worst section of pipe was from the manhole on the bank at the Glebe land, to the manhole where the road collapsed and the new liner starts. This section is too weak and damaged to be relined, and so it will be excavated and replaced

The trench is being sheet-piled here ready for installation of the first length of new pipe. The "trouble" manhole is at the bottom edge of the first picture.

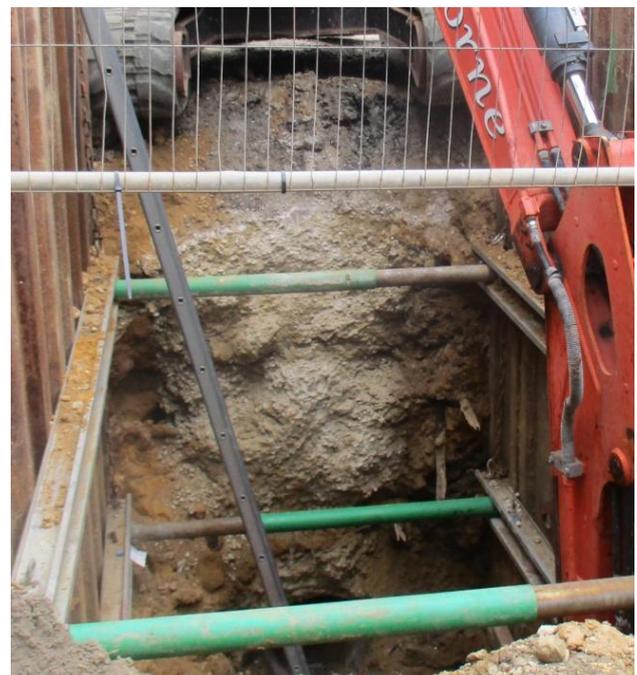
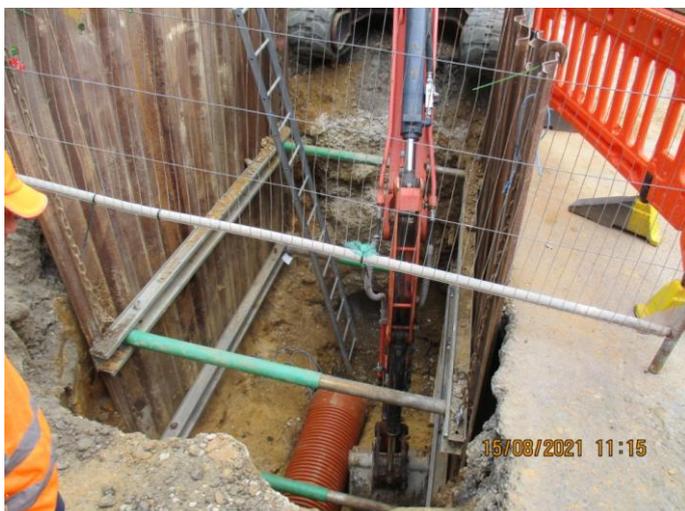
The pictures to the upper right and below show the new pipe being installed, and illustrate the depth. The picture to the immediate right shows a huge block of concrete left by KCC in earlier works that caused most of the delays on this short section

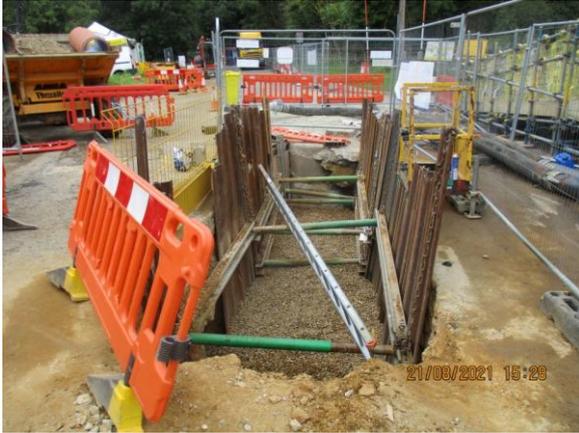
The final 30 metres of severely damaged pipe has been replaced and partly backfilled. In the next few days that will be covered with concrete before the final base and top coat tarmac. But there has to be a 7 day cure before the concrete can take normal traffic. KCC are threatening penalty charges, but SW insist they will do the job properly, and that it will take as long as it takes - their new motto being "Do it Once, and Do it Right"

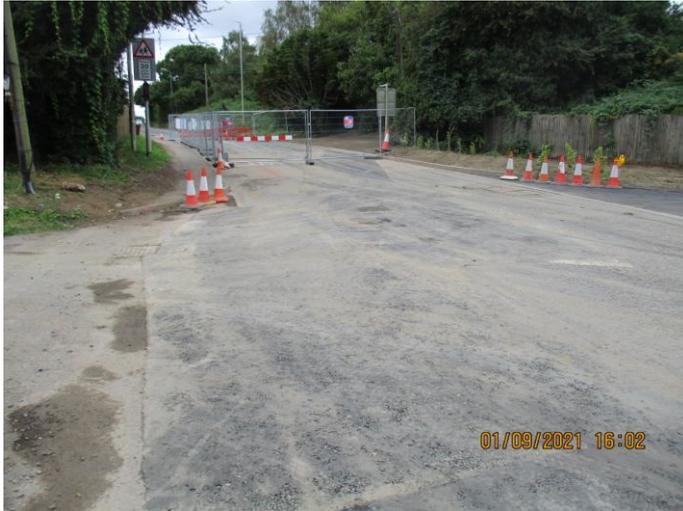
The final picture, the A25 all repaired, mostly cleared and just awaiting new white lining, preparatory to its opening on the 3rd of September.

All new tarmac, waiting for the white lining crew

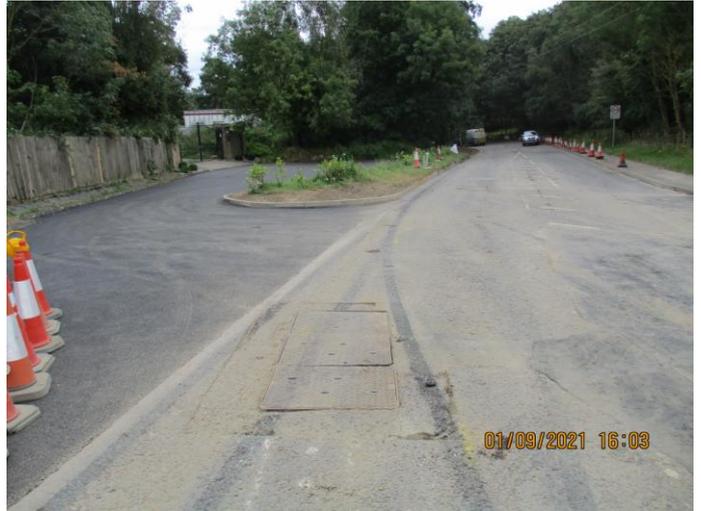
The entrances to the houses within the road works areas are having all sorts of repairs and upgrades, including tarmac and new kerbs (*see pic below*).

Some entrances refurbished

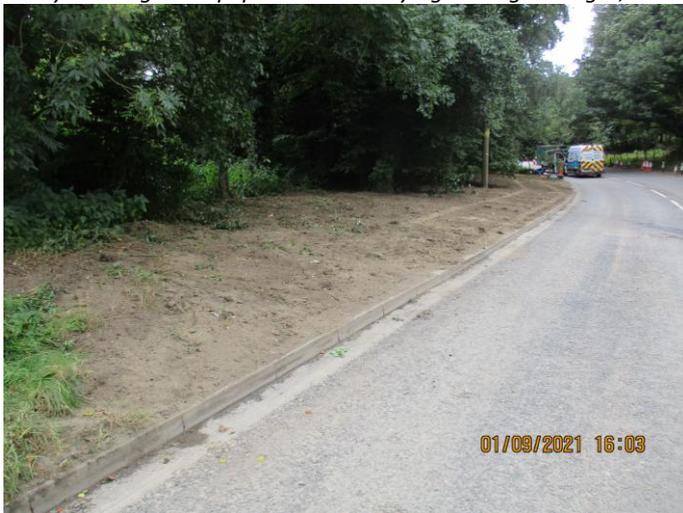
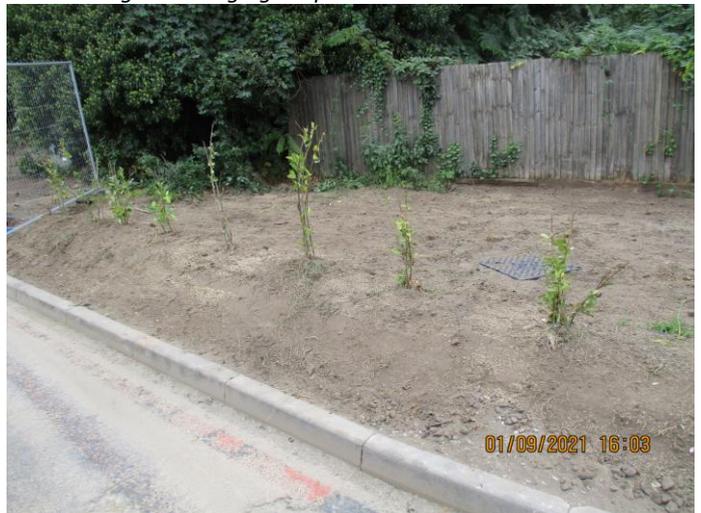
Slowly clearing the equipment and relaying damaged verges,.....including new hedging whips
