Isles Quarry Contamination Concerns

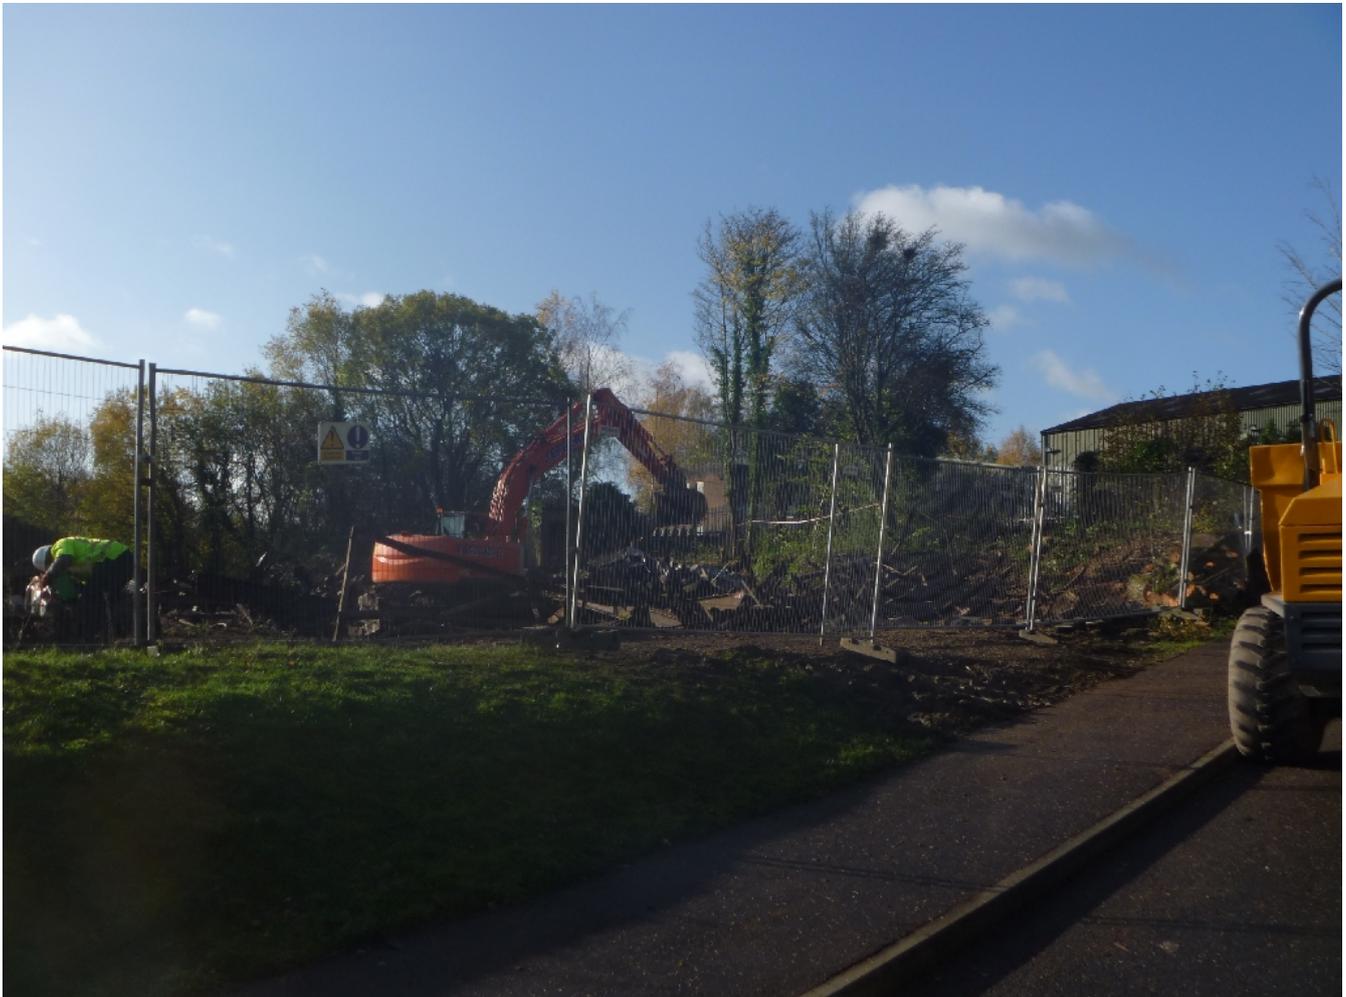
We know that work began on Area1 in early November 2013, firstly demolition of the steel buildings, and I have a picture taken 14 Nov showing final clearance of the steel.

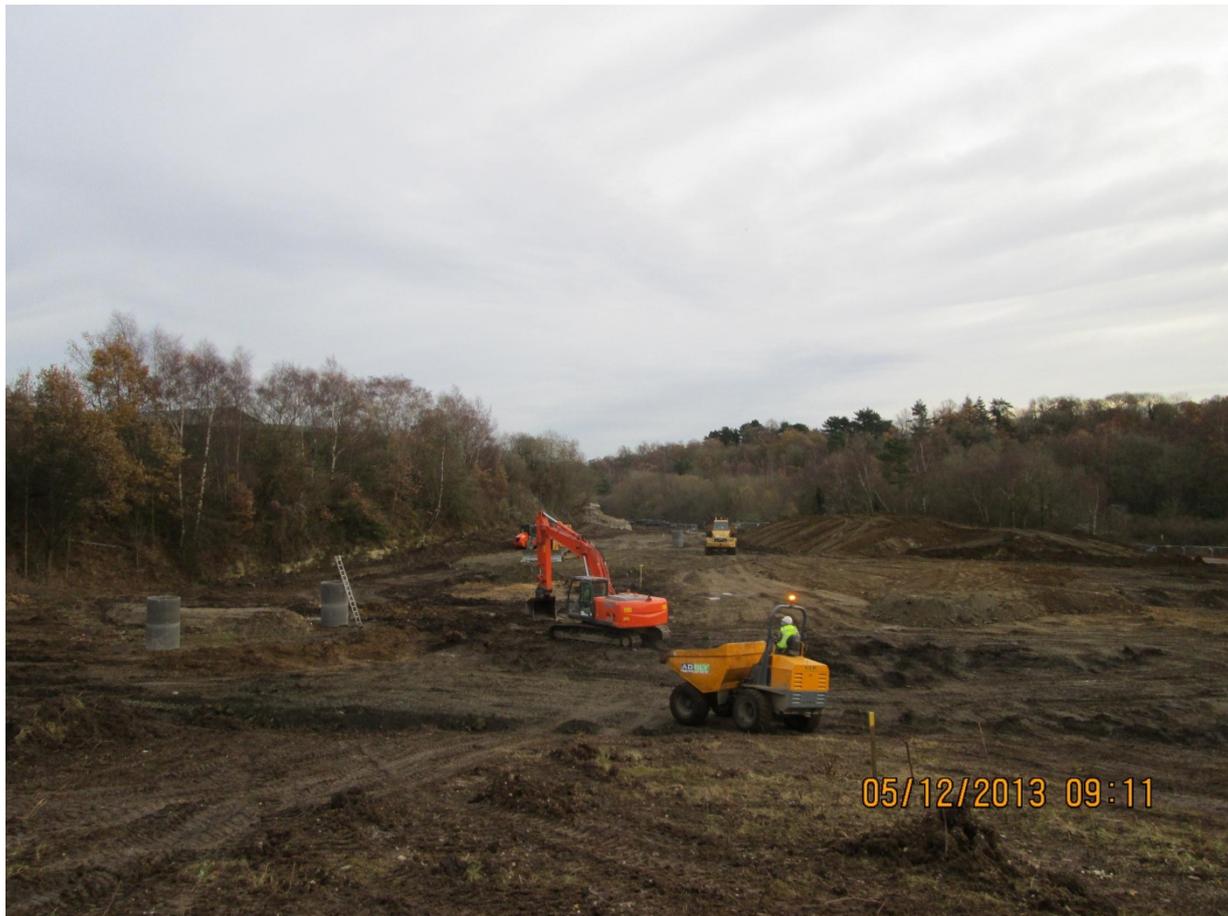
Pictures taken by Crest Nicholson on 5th December show a large area of dark material being spread in area 2&3

Based on the evidence to hand, both my own, and that supplied by T&M/Crest, leads me to suspect that the heavy oil contamination from Area 1 was removed unsampled, and buried in Area 2/3 under the clean(ish) material from the Hanson stockpiles.

I need further convincing that the bund material was the Area 1 contamination. The evidence I have seen to date leads me to suspect the Area 1 contamination was buried in Area 2 & 3 on the 5th December, and the bund filled with material from elsewhere at some later date.

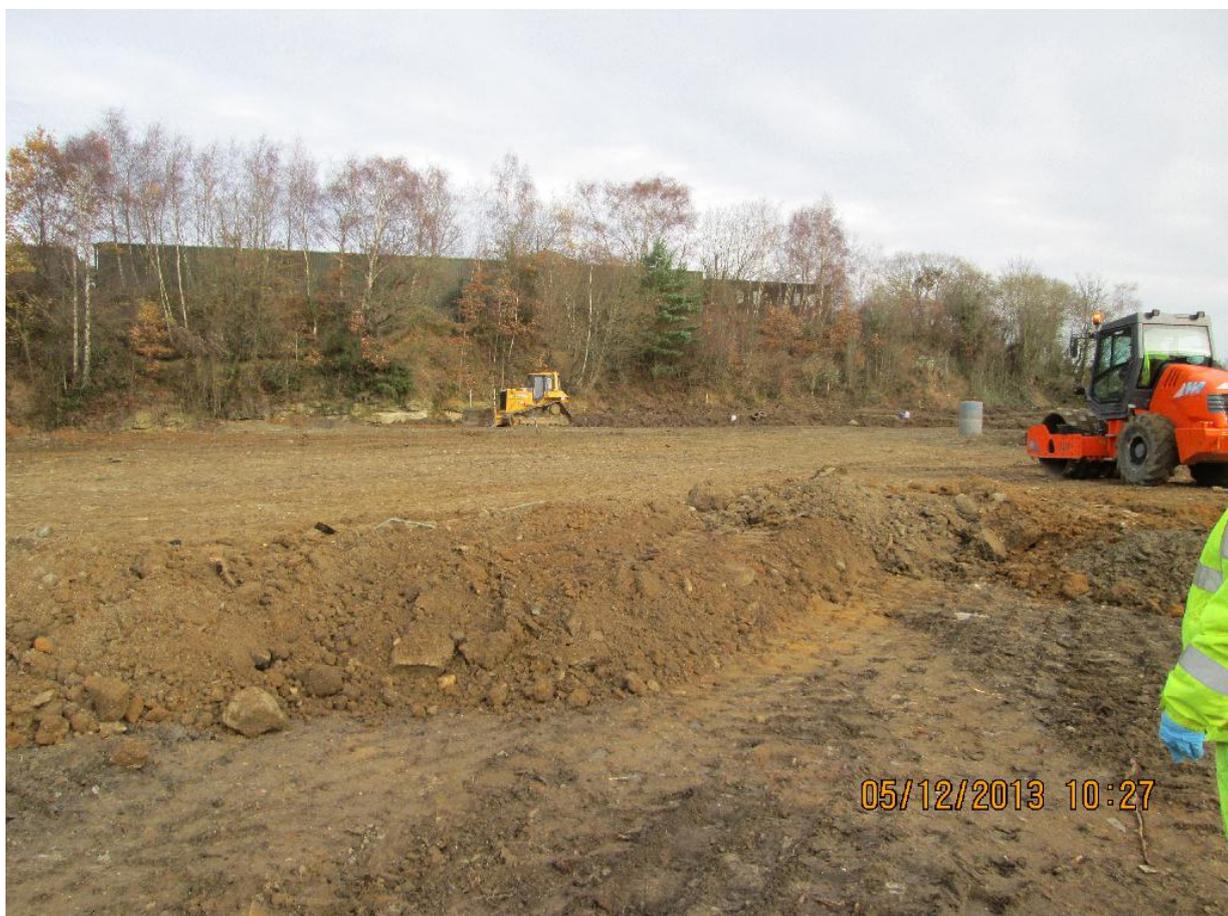
Other pictures taken an hour later at 1027 show clean material cover of the same area.

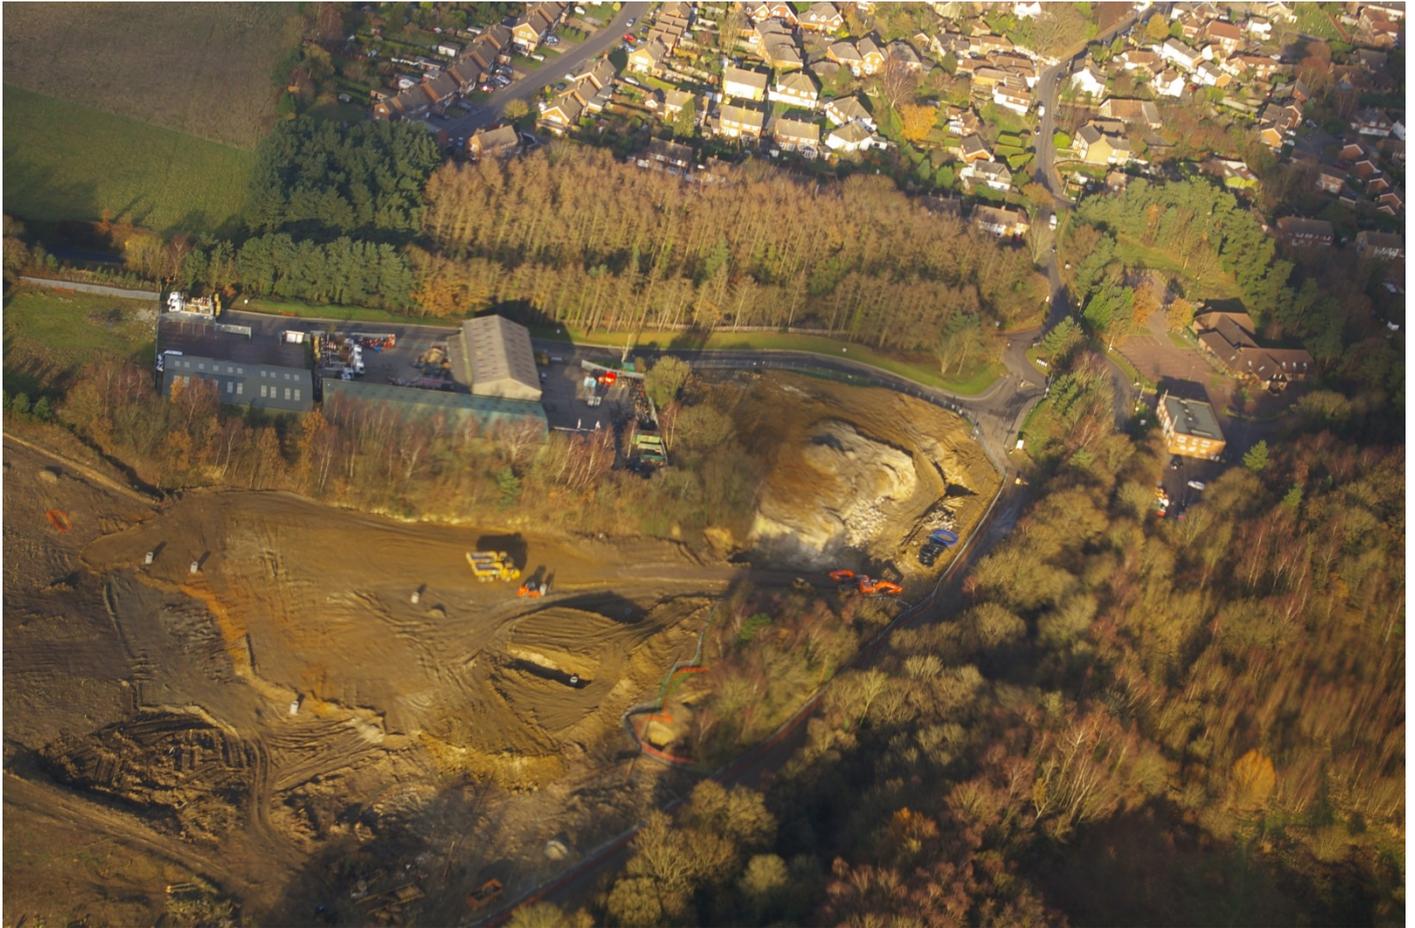
This clean covering is also very evident in our aerial picture of 8th December, which also shows that Area 1 is now excavated to construction level.

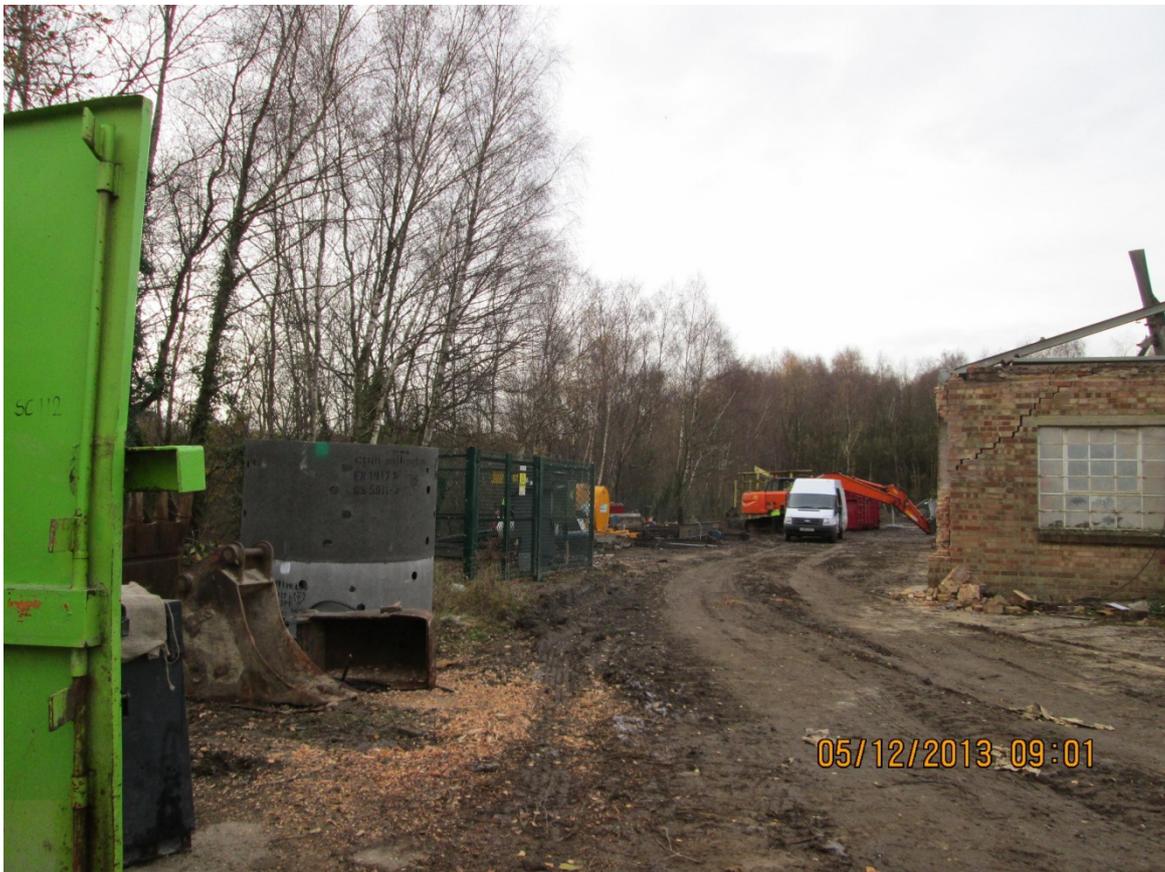
However, Crest's own picture of the compound on 5th December shows an excavator being repaired on the spot that the bund will be built, and I can see no evidence of the bund behind it.

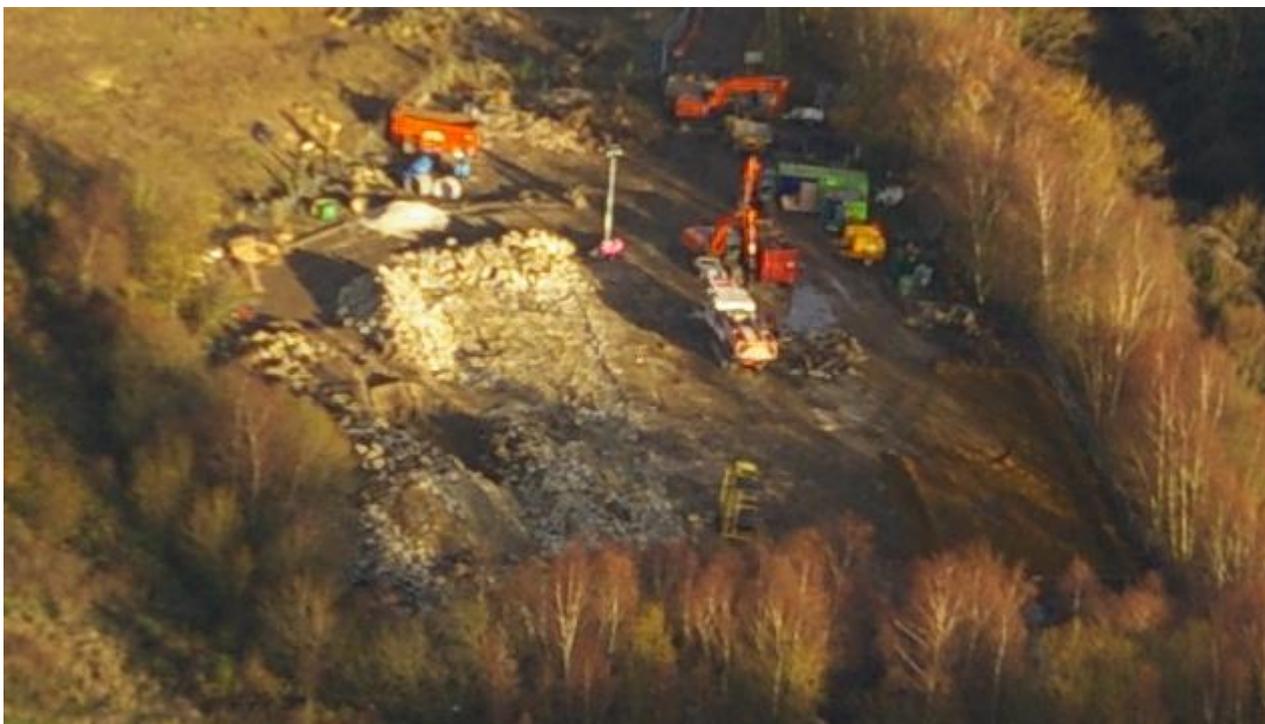
Our aerial picture on 8th December shows the bund under construction. Crest reasoned that our aerial picture showed the bund in use, but with one end left open to allow material to be delivered.

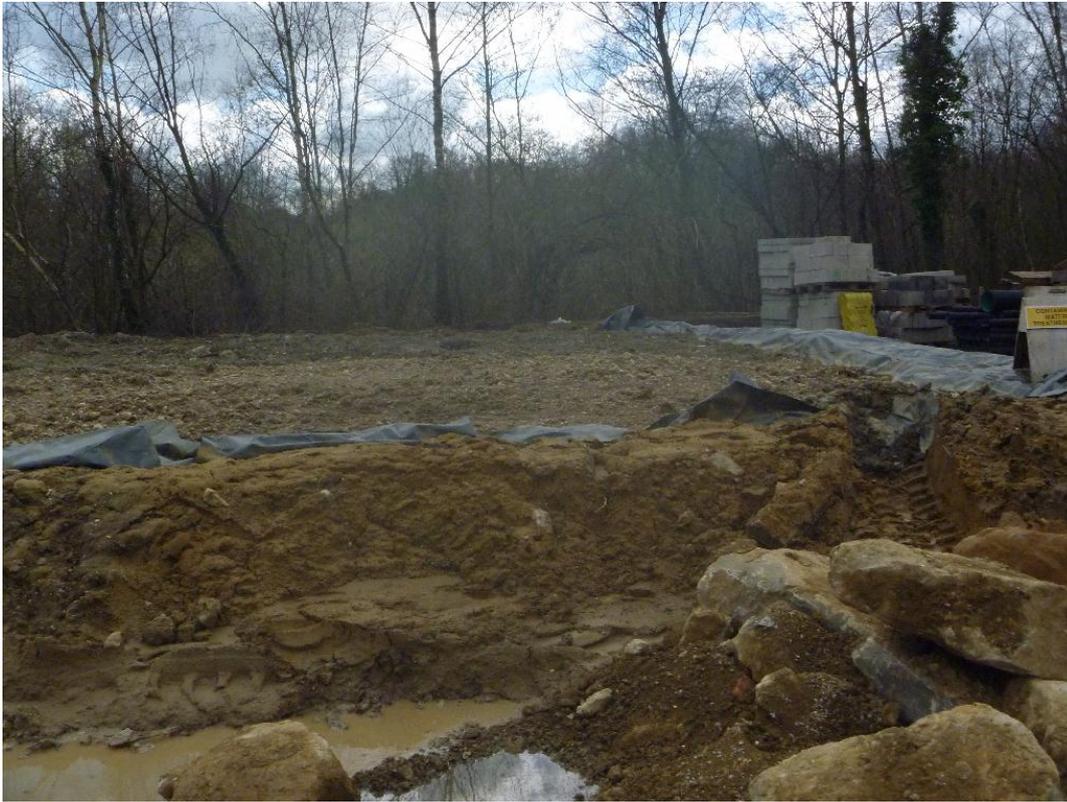
However, the bund is supposed to have a plastic liner, and as our picture below of the bund on 28 March (below) shows that liner is black, and overlaps the bund walls to create a "pond" , and this is clearly not in position on 8th December. The black liner should be clearly visible around the whole perimeter above if it was installed, and across the entire base, even if we accept the premise that the bund wall will not be completed whilst the bulk is being filled. Albert Prince swears he has dated pictures of the bund in earlier times, but 3 weeks later these still have not been forthcoming, and as they were allegedly taken on 28th November, why have they not been produced in the many months that I have been expressing my doubts?

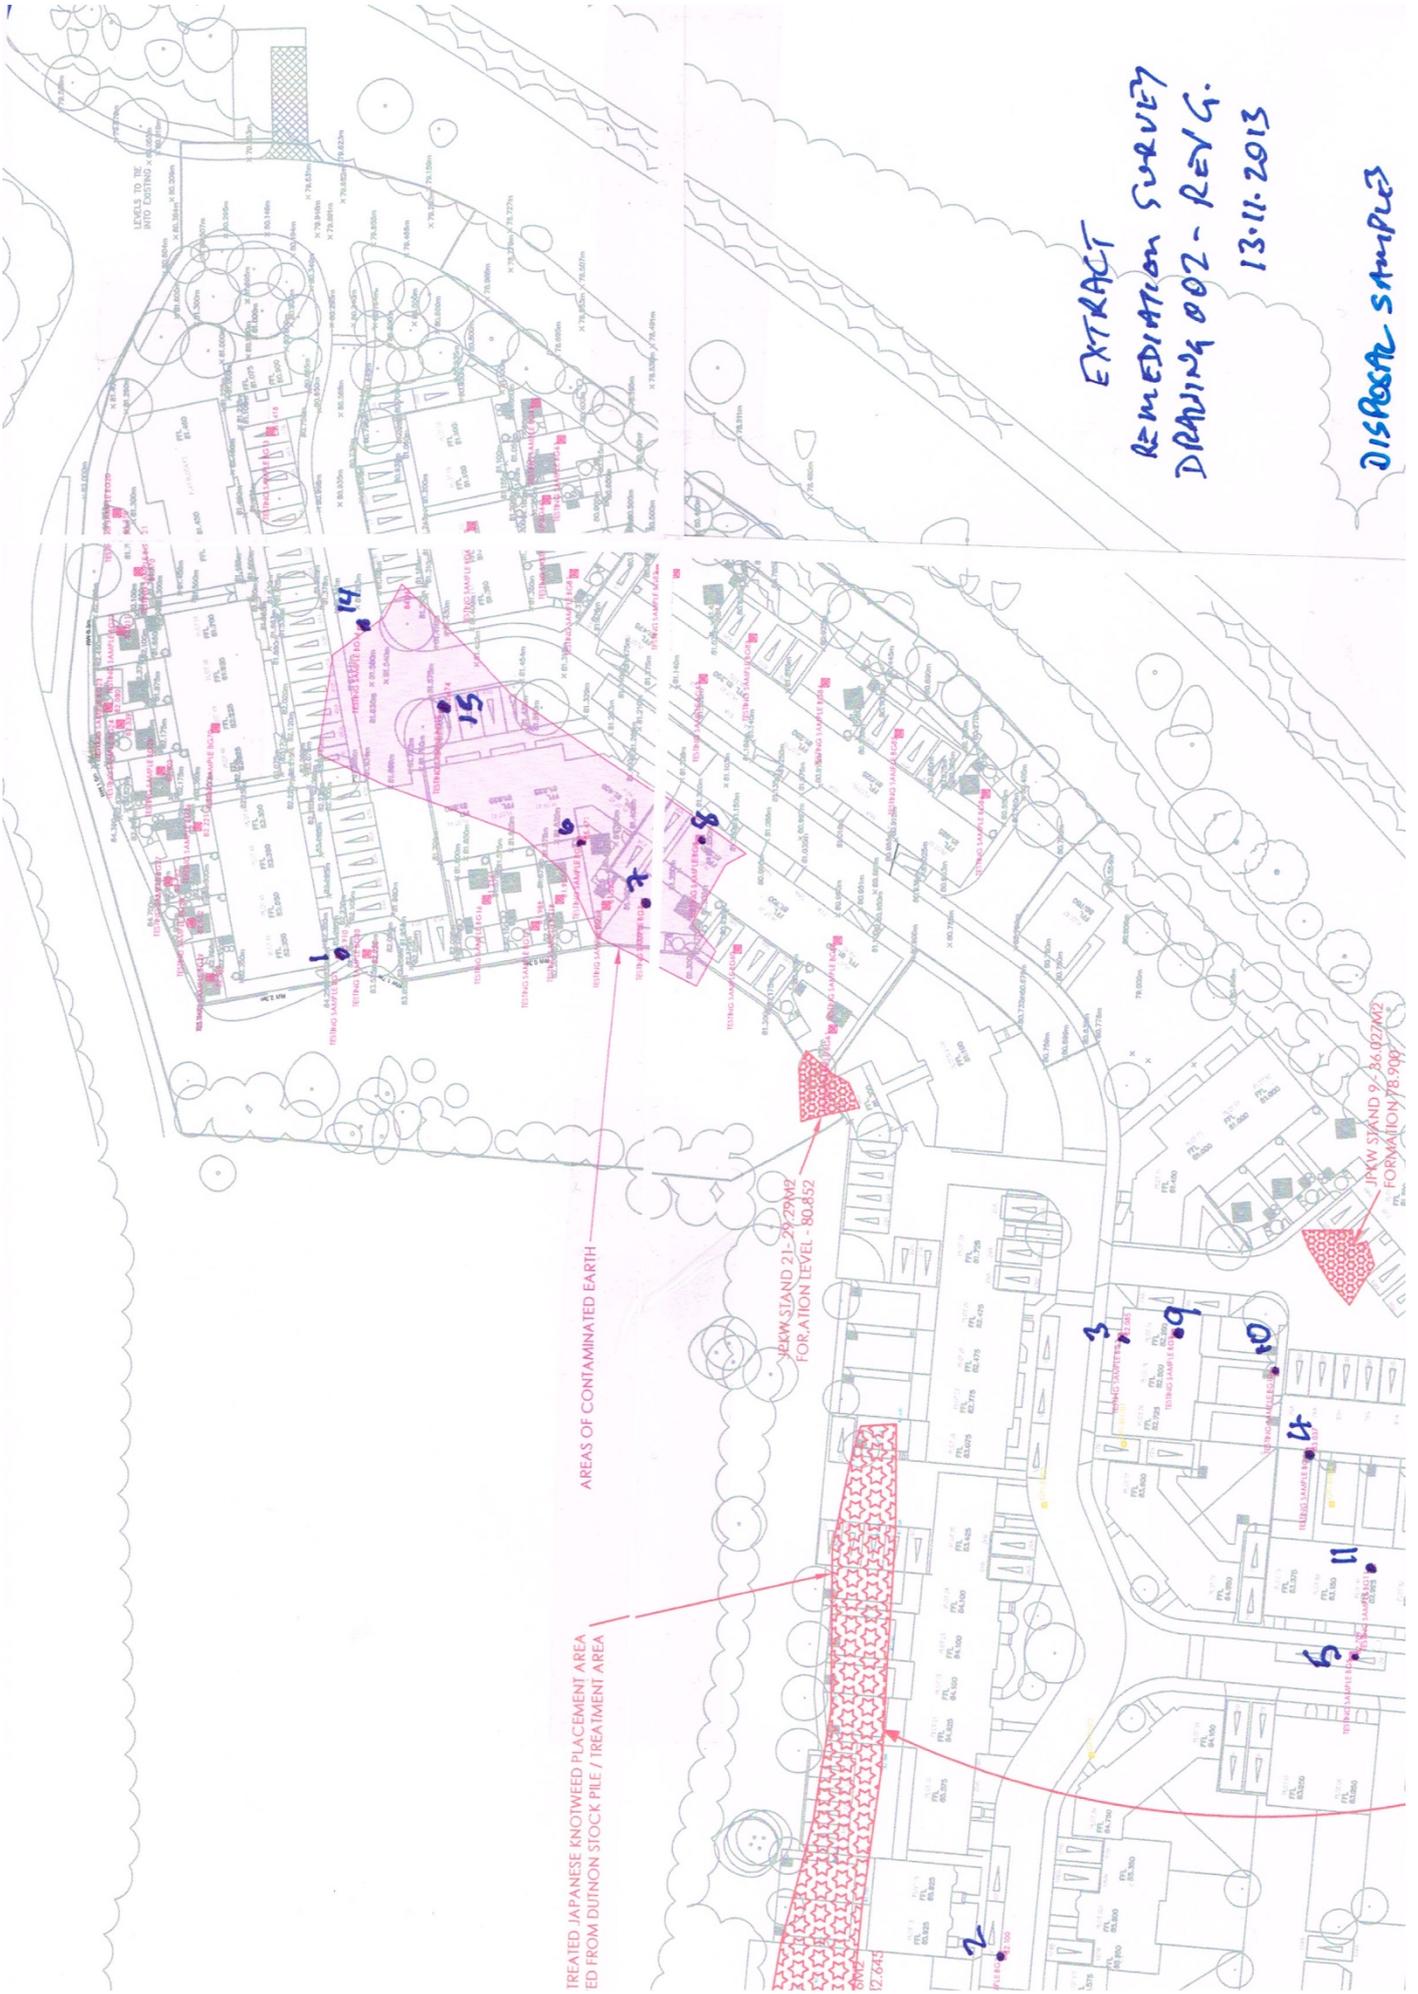
EXTRACT
 REMEDIATION SURVEY
 DRAWING 002 - REV G.
 13.11.2013

We know from the Ground Obstruction Report that the hardstanding and asphalt was also removed in November. The first sample taken was BG1 on 22 Nov, but that was taken from the extreme western boundary. (see Remediation Survey Drawing 002 - Rev G). Drg 002 also shows that samples BG2,3,4,5 taken 27 Nov from Area 2 & 3, and that BG6,7 & 8 were taken 2Dec at low level, after excavation.

It is very important to read the sampling results in conjunction with the locations and depths noted in Drg002-RevG, and the sampling dates noted on the test results. A sample taken after excavation at low level, could easily be mistaken for a sample taken at high level before excavation, and a wrong conclusion reached that as the sample is clean, there was no contamination.

Drg002 notes a pink area as "Contaminated Earth", but there are **no samples** taken in this area. This pink Area corresponds with the contamination noted in my report to the LDF Inquiry, and one wonders why it is highlighted on the map, but not sampled.

It would have been extremely useful if samples had been taken from that pink area before excavation, and compared to the disposal tests BG32,33,34 & 39 when that material left site, that would have provided evidence that the known contamination material had been removed from site.
