SEWAGE UPDATE 29nd May 2021

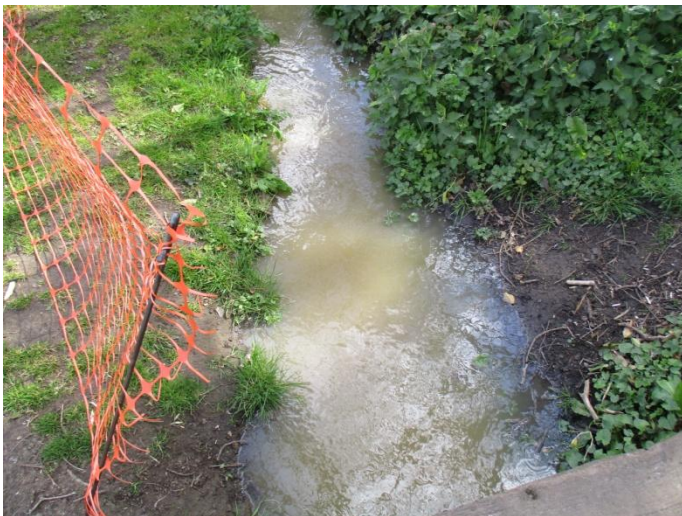
Recreation Ground Stream

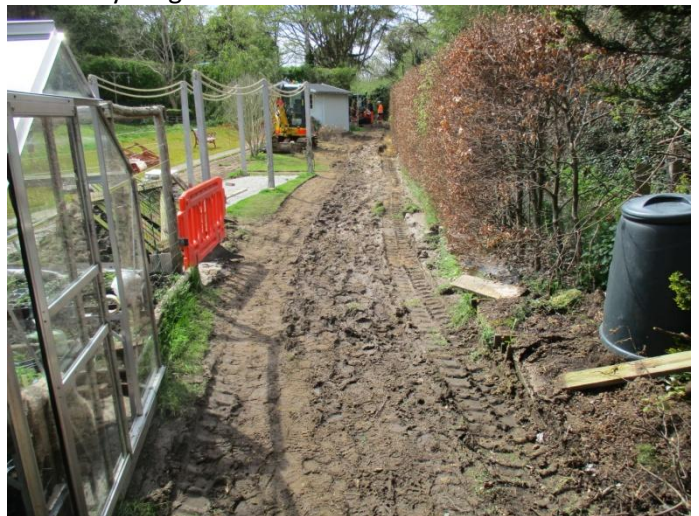
Sandy Ridge Site

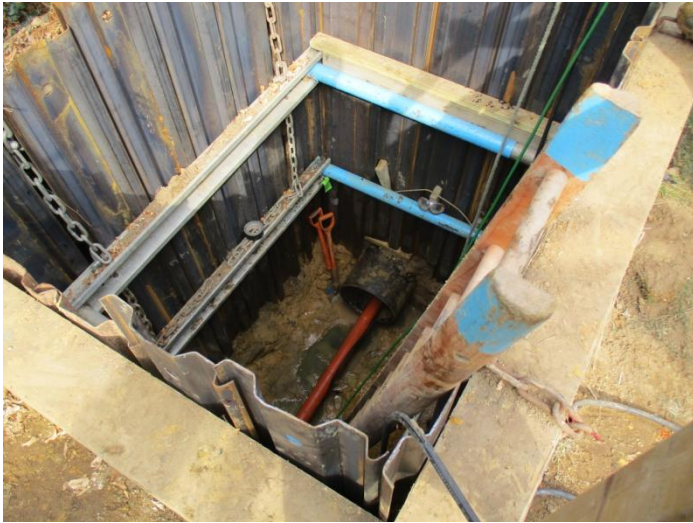
First Sandy Ridge Excavation

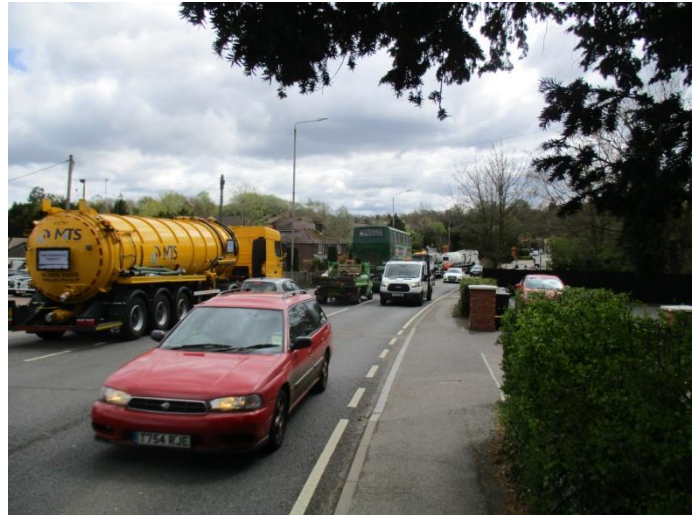
Tanker arriving at Maidstone Rd

The Maidstone Pumping Station has had to be shut down to allow work on the damaged pipe, and this has necessitated a huge fleet of sewage tankers bypassing the pipe running sewage from Maidstone Rd, Basted and Ightham.

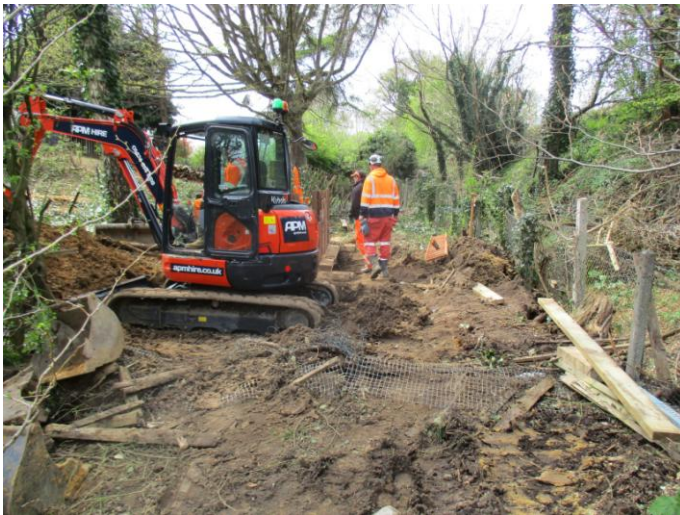
Site of third sewage breakout

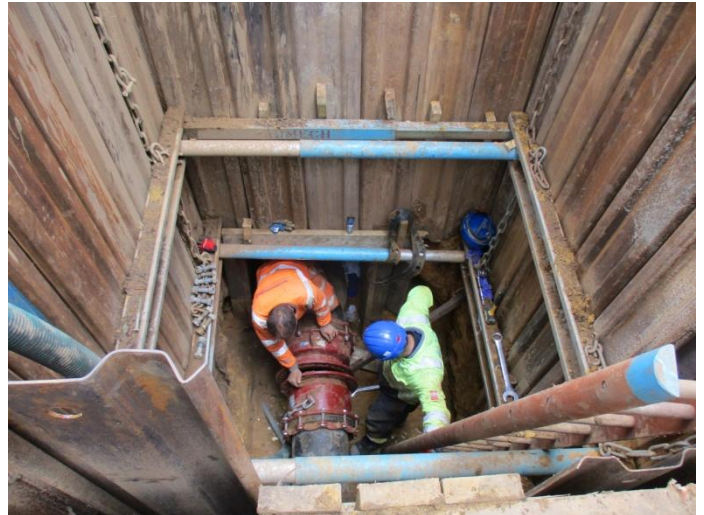
Third and fourth beakouts

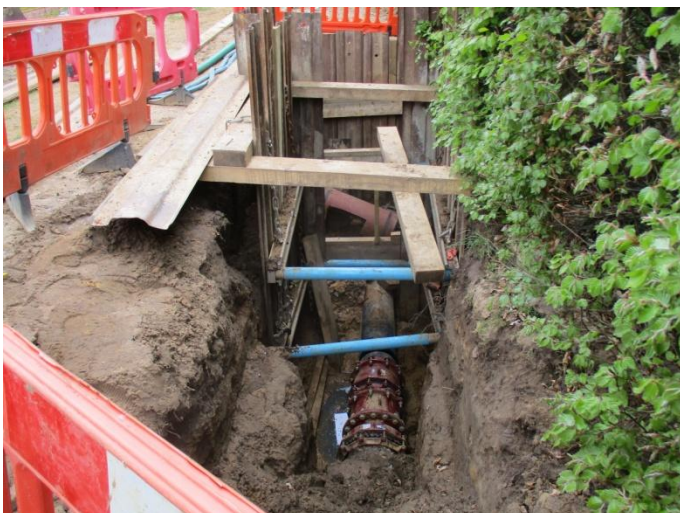
Second Excavation extended for pipe insertion

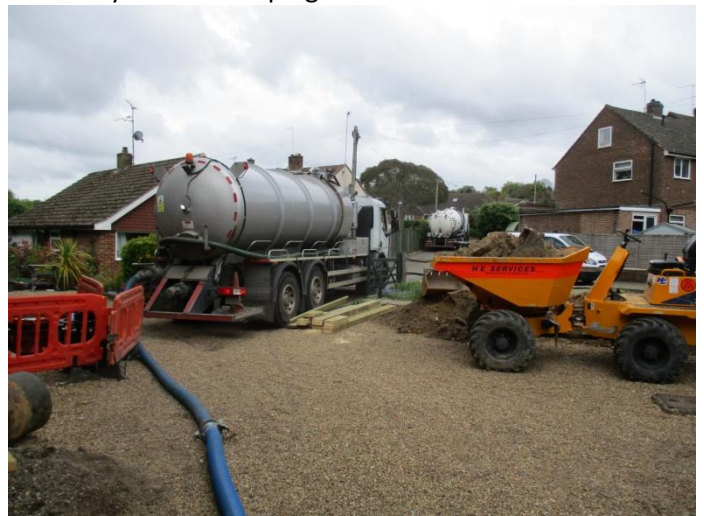
Standby tankers keeping excavations clear

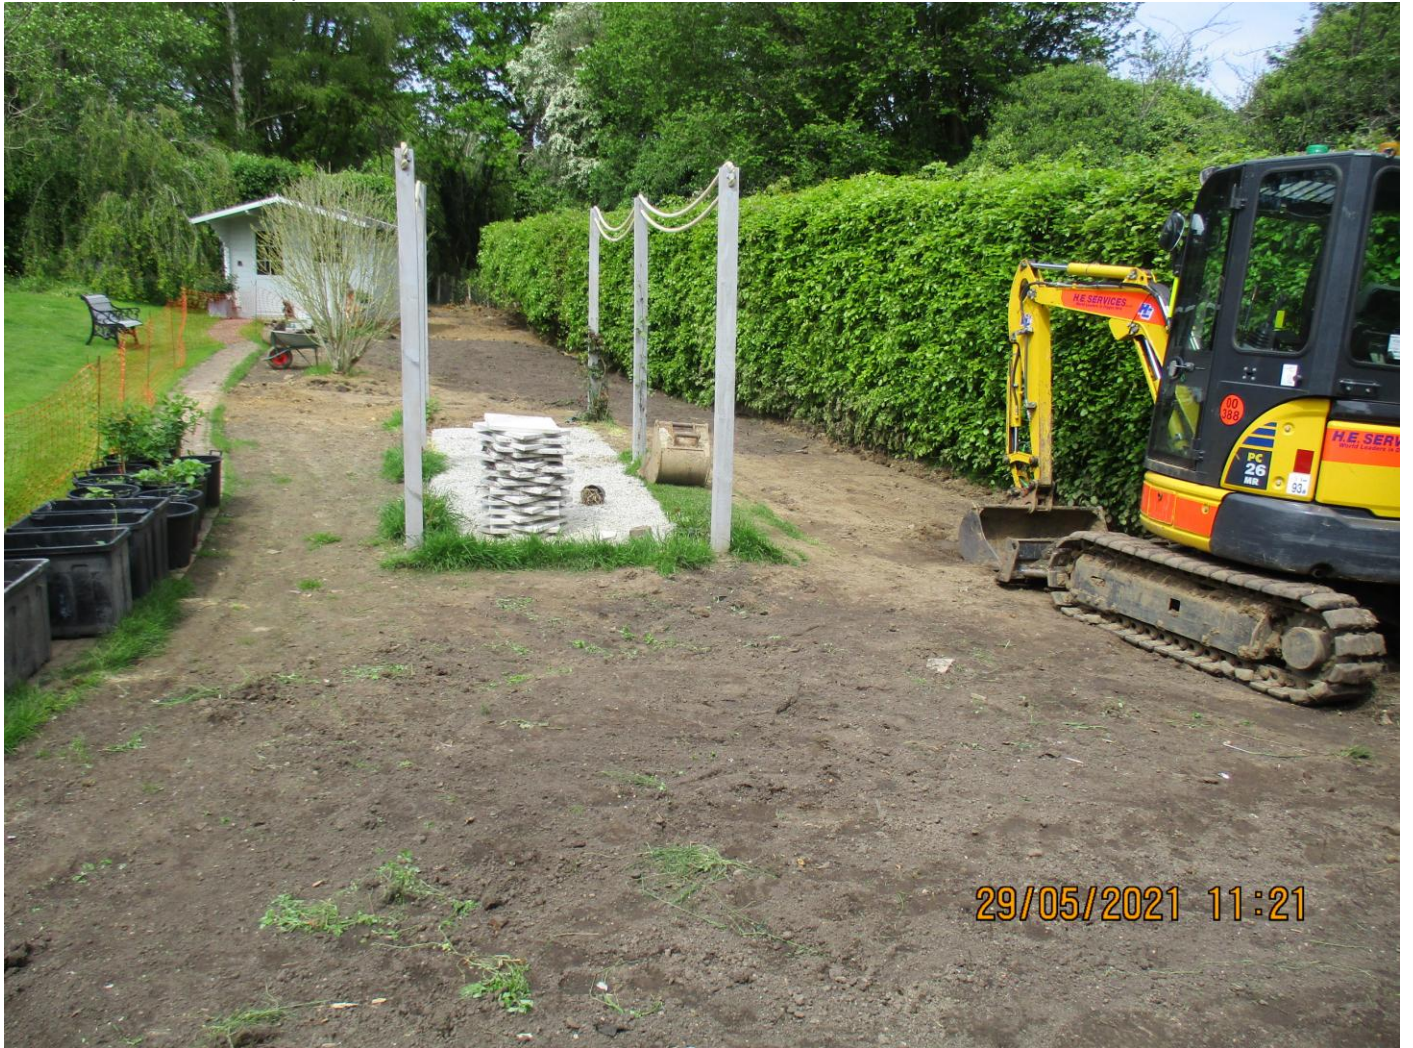
Reinstatement underway

Since 29 April we have had **five** successive sewage breakouts on the main sewage line between the Maidstone Rd Pumping Station and its eventual route past Whatcote Cottages and Askew Bridge to Wrotham Heath. These breakouts have all happened in a garden of a house on Sandy Ridge, and there is a major Southern Water operation taking place there. The proposed solution that we have been advised of today is that a 25 metre sleeve will be inserted in the damaged pipe to ensure sewage cannot escape again. Works there have now been completed, and reinstatement and landscaping have begun.
